Dufour, Laskay & Strouse, Inc.

Condition and Valuation
As of
August 23, 2013

ALGIERS POINT FERRY LANDING

SURVEY REPORT NO. 1411-01N13-1

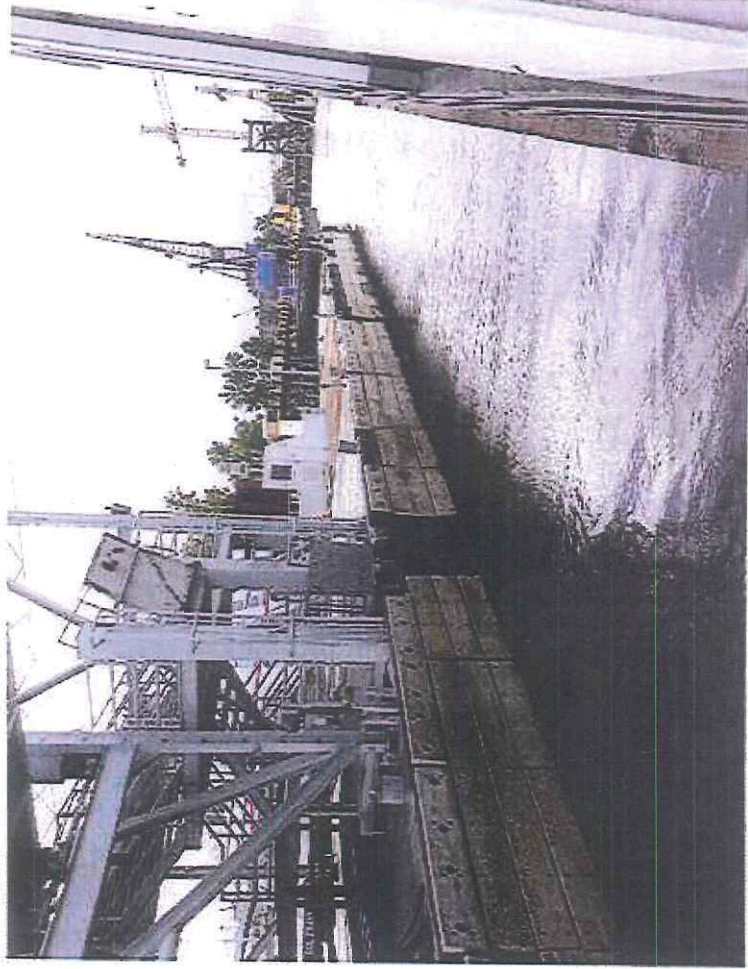
1. HULL AND FENDERING

The vessel's hull was noted to be in good condition and coated with older and fading coatings. Insets of 0-1" were noted in scattered areas throughout. Light rust and marine growth was noted throughout as well.

The area of the car ramp was note with its forward and aft rubber fenders torn and some partially adrift. The vessel's wooden timbers (approximately 60%) were noted with some degree of damage and spitting. The car ramp was noted to have a slight 0-2" set down on the forward portion.

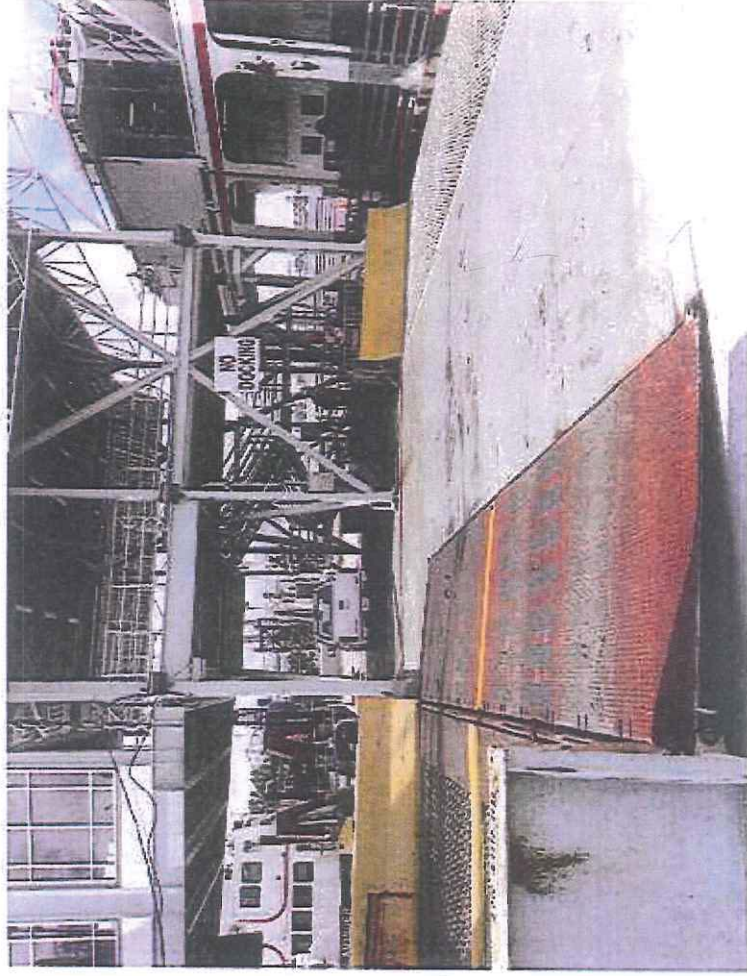
4. MAIN DECK

The main deck was well coated with older and fading non-slip coatings and sighted with light surface rust in areas throughout. Heavier rust and scale was noted in areas near midships. Insets of 0-1½" were noted just inboard of the starboard coaming with moderate amounts of dirt in way.

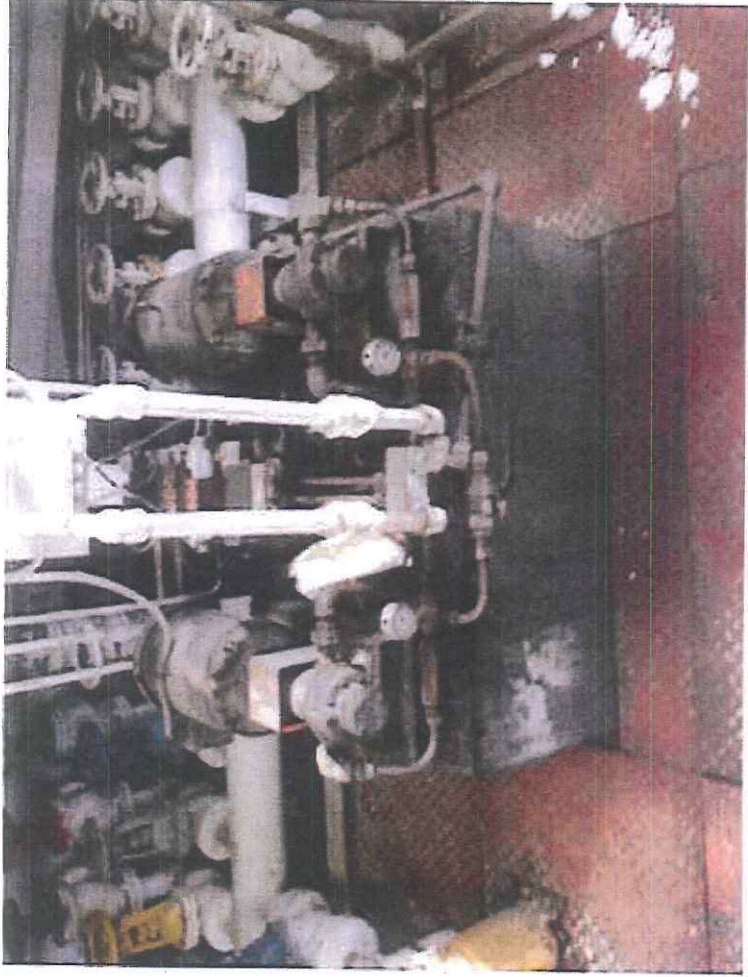
9. HPU

- One bilge/ballast manifold operated via a 5-HP electric motor *(Non-operational)*
- One hydraulic power unit fitted with two 5-HP electric motors driving pumps and set over a common oil reservoir *(Non-operational)*

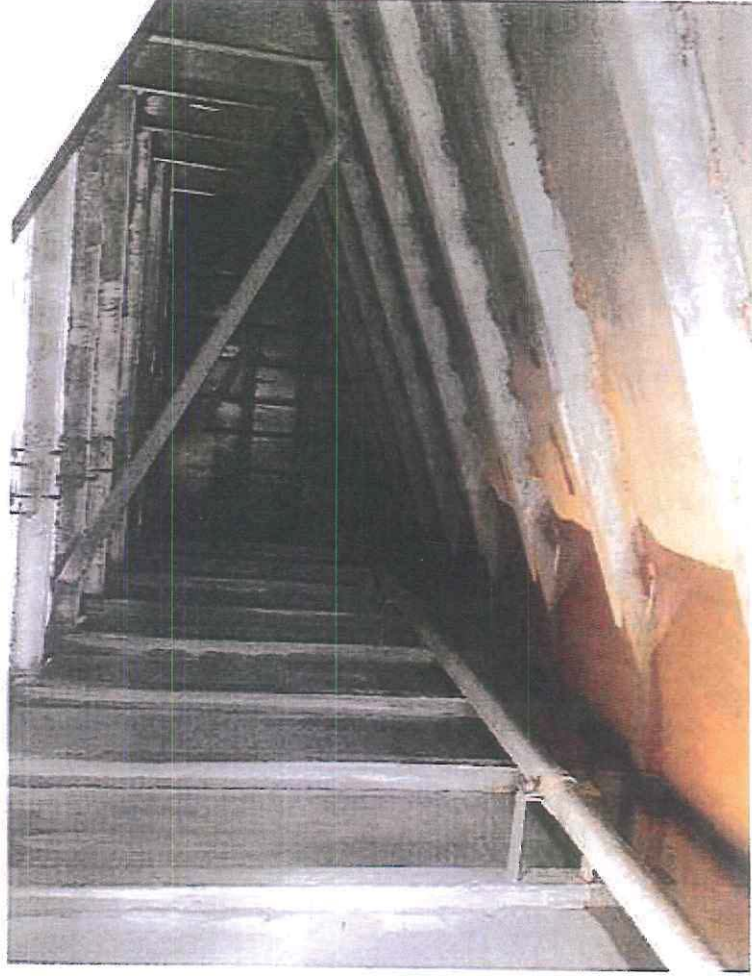
10. INTERNALS

The compartment was noted to be well coated and in good condition. The upper outboard side longitudinal was bowed due to a hull set in over the majority of its length. Two side support angles were crimped and crushed 0-4" to conform and corner brackets were also noted to be set in. The compartment contained 0-5" of water throughout.

1. Replace as found necessary any broken and/or dried and cracked gaskets in way of manhole covers.

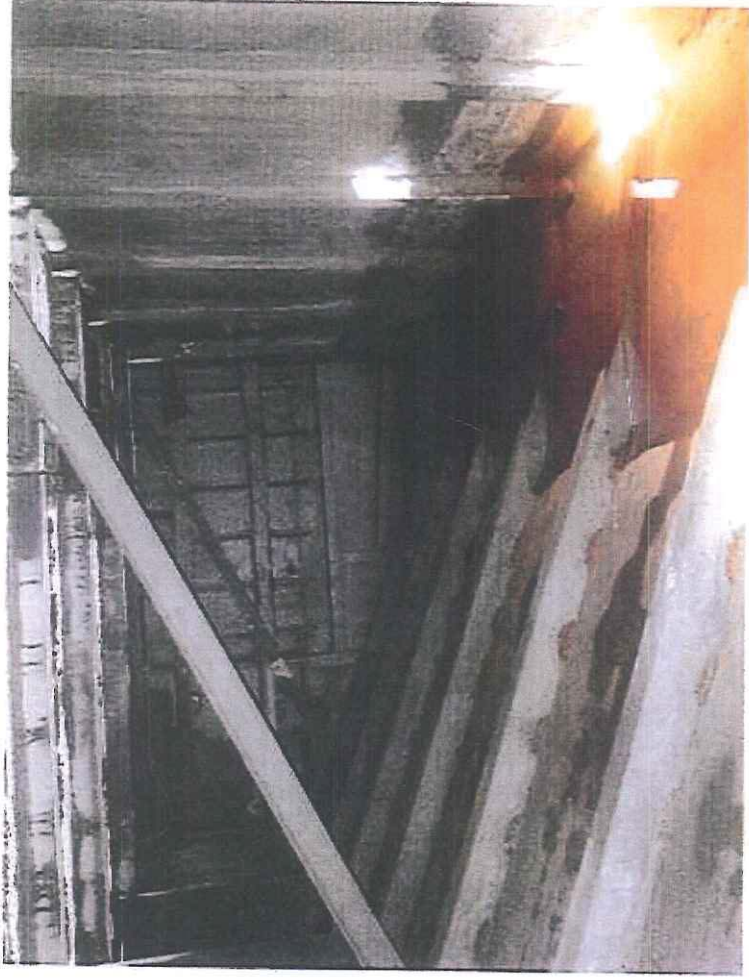
11. INTERNALS

The compartment was noted in the same condition as the starboard No. 1 compartment with the exception of two side longitudinals being crimped and distorted and no water in the compartment.

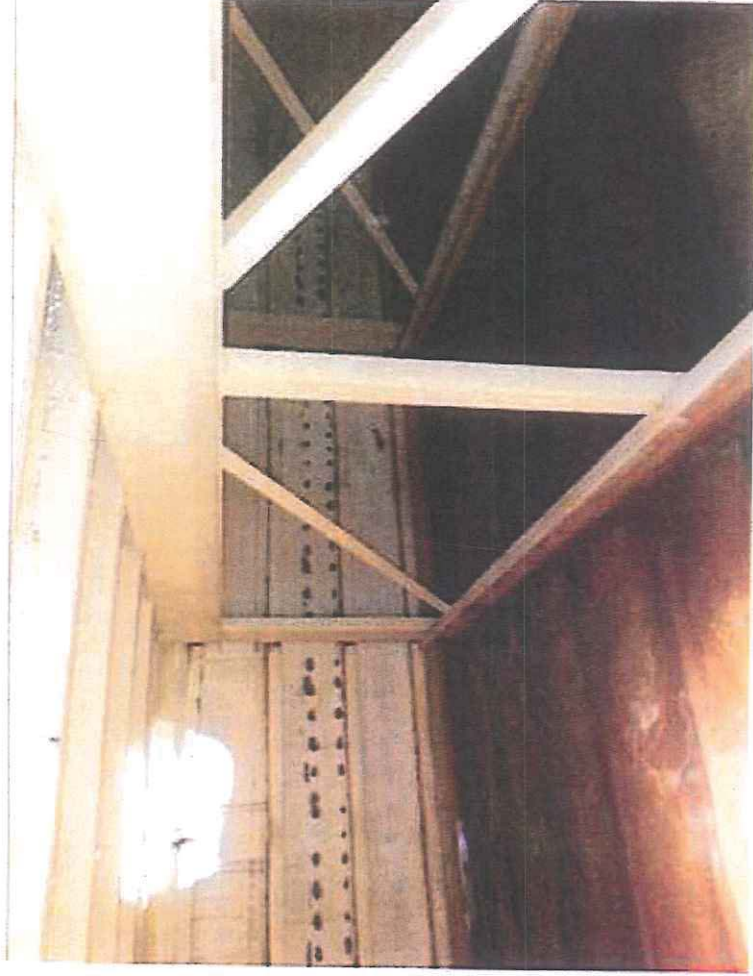
12. INTERNAL

The compartment was noted to be dry and well coated but with some light rust and scale on its inboard bulkhead. The compartment also allows access to the No. 5 port side compartment which was located under the car ramp by means of a bolted manhole cover.
