Dufour, Laskay & Strouse, Inc.

Condition and Valuation
As of
August 21, 2013

LOWER ALGIERS FERRY LANDING

SURVEY REPORT NO. 1411-01N13-F

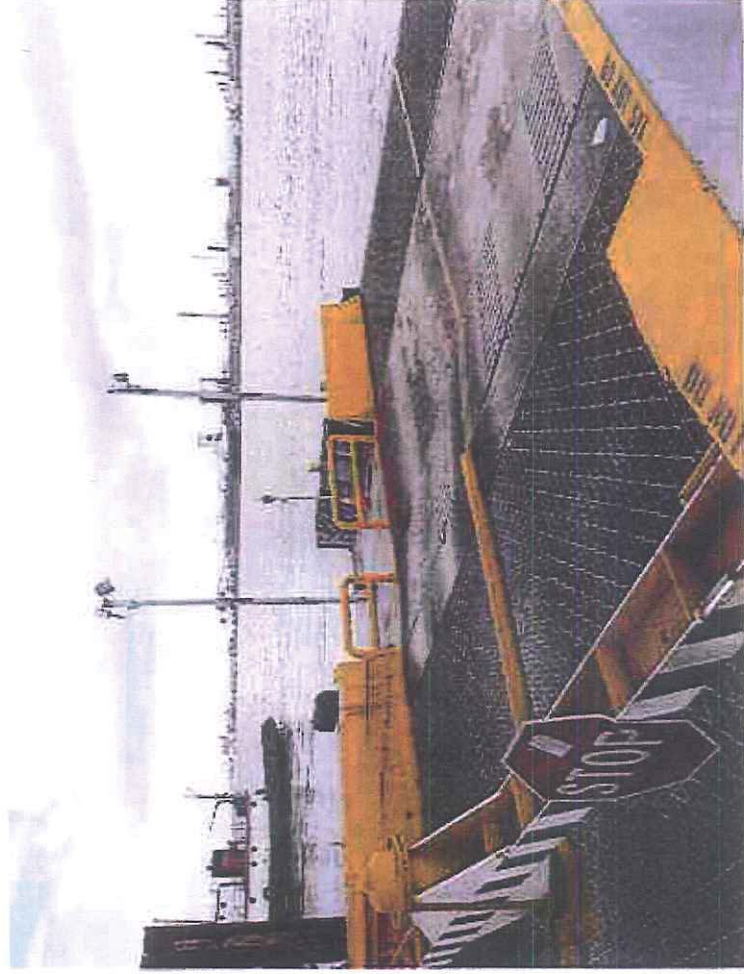
3. CAR RAMP

The forward end of the vessel's deck is fitted with a hydraulically operated car ramp which has not been operated in numerous years. The ramp itself measures approximately 45' in length by the entire width of the barge and is made up of two separate sections in order to allow folding when operating. Hydraulic rams are noted beneath the ramp.

The vessel's hydraulic car ramp was noted with the starboard side heavily dented and set down, mostly at its forward end of 0-8", to varying degrees.

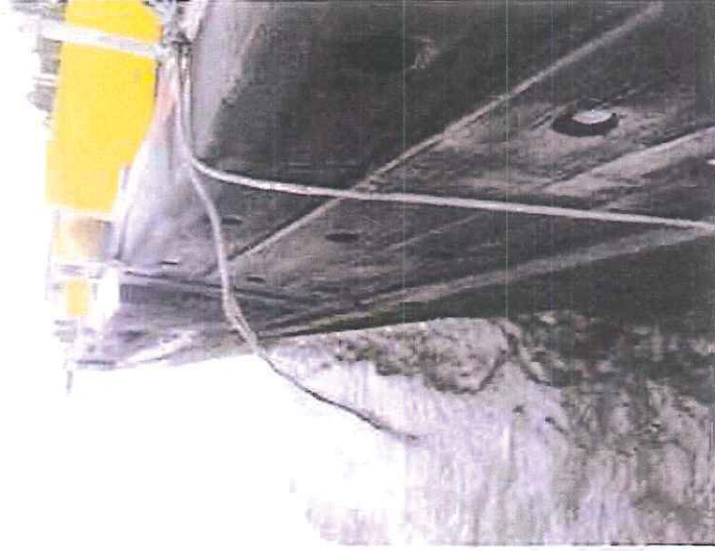
5. FENDERING

The fendering on the starboard side of the vessel was noted to be in good condition with some of the timbers splintered and/or broken in some areas.

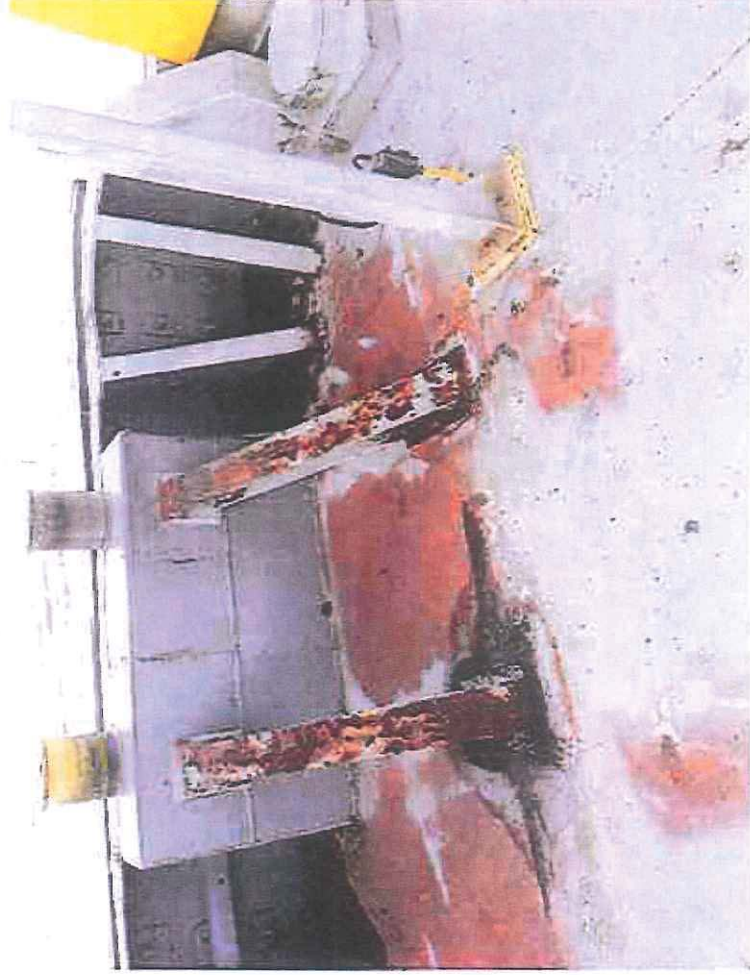
6. BULWARKS

The starboard side of the deck was noted to be set down along the bulwark frames with some sections of framing noted to be crimped 0-2" to varying degrees. There was also some light washboarding noted on the deck between longitudinals of 0-1 $\frac{1}{4}$ ". Some scattered 0-1" insets were also noted.

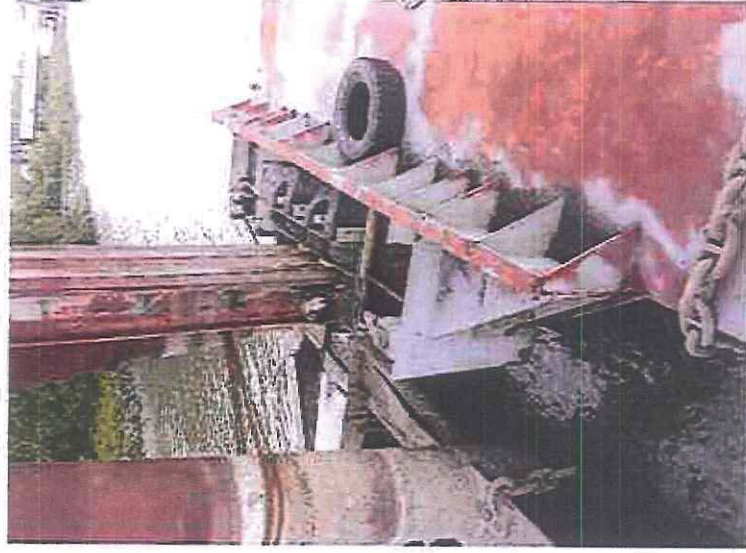
9. MAIN DECK

Overall, the main deck was noted to be in good condition and well coated with older and notably fading coatings, with very light rust throughout.

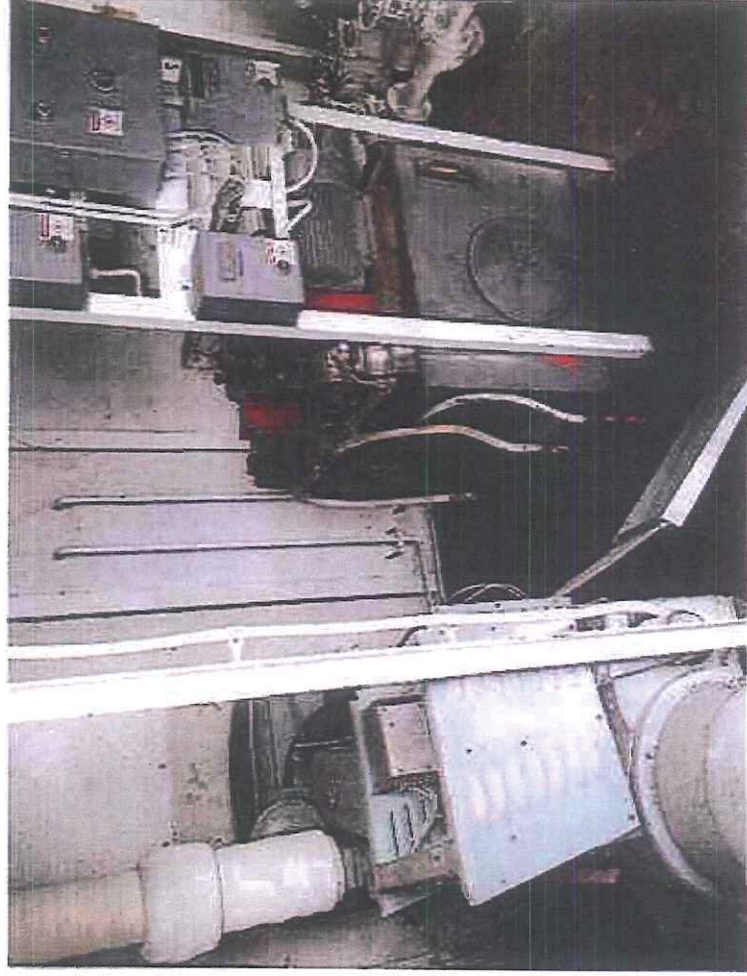
13. AUXILIARY MACHINERY

- One hydraulic power unit used for the vessel's car ramp which is operated via two approximate 5-HP electric motors set over a common hydraulic reservoir (*Non-operational*)
- One 30-KW generator run via a Detroit Diesel, model 3-71 (*Non-operational*)
- One bilge ballast manifold operated via a 2-HP electric motor (*Non-operational*)
